# Service Bulletin

Bulletin No.: 19-NA-206

**Subject:** Intermittent Shift to Park Message Displayed While Vehicle in Park

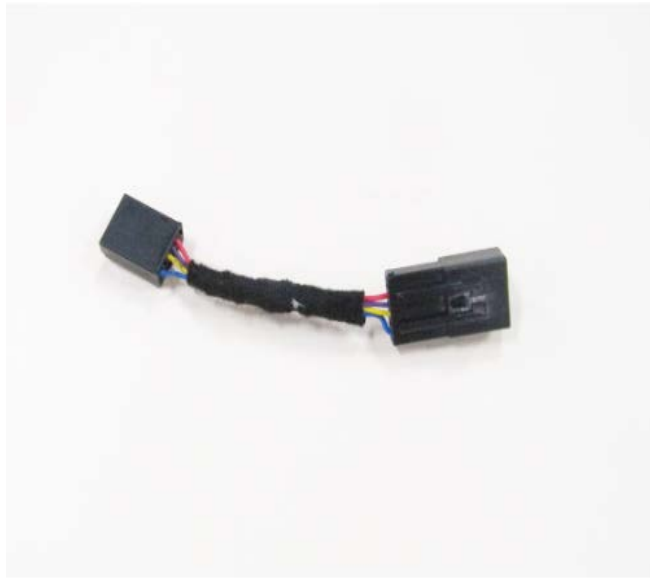
5386336

<b>Involved Region or Country</b>	North America, Europe, Russia, Middle East, Israel, South America, Japan, South Korea, China, Thailand, Australia, New Zealand, Africa
<b>Condition</b>	Some customers may comment on seeing an intermittent Shift to Park message when the vehicle has been shifted into Park, and the ignition has been turned to the Off position.
<b>Cause</b>	The cause of the condition may be that the park switch in the transmission control (shifter) assembly is not pulling the BCM signal low to electronically show that the vehicle is in the Park position.

Verify the condition and following the steps in the Service Procedure below, install an In-line Shifter Wire Harness Jumper between the shifter base connector and the console harness connector.
